DEVELOPMENT AND TEST OF THE HUMANITARIAN DEMINING SIFTING EXCAVATOR

Christopher Wanner
Night Vision and Electronic Sensors Directorate
October 2003

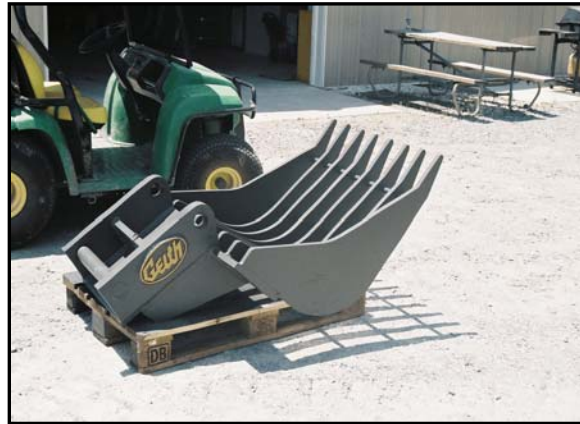
Figure 1. Vaned Bucket

In addition to the standard quick release digging bucket, four special purpose tools have been designed and fitted for use with the Sifting Excavator. Three of these require a hydraulic power source to separately power the attachment. The one tool not requiring hydraulic power is the Vaned Bucket (see Figure 1) which is to be the main excavating tool employed. The Vaned Bucket fits on the excavator arm and curls outward, away from the vehicle in contrast to standard digging tools made for the excavator. This action is required to pick at the base of the trench wall facing the vehicle and perform all digging on the upward stroke from underneath the mine. The Vanes are spaced 4.25" to enhance the utility of the bucket for picking/sifting large items from the residuals pile such as AT mines which have dropped from the bank. The Vaned Bucket features a nearly flat bottom for straight insertion into the base of the bank with an aft to front taper of 3". The low side walls, and the open appearance of the bucket are designed to enhance the operator's vision of the workspace and identification of mines. The Vaned Bucket requires no separate power source and is manipulated solely with the existing Liebherr controls. The bucket was designed by Radian in consultation with Night Vision, and fabricated by Geith Inc. of Petersburg, Virginia.

The most effective and safest digging technique compatible with the Vaned Bucket was found to involve working on approximately 3-4 meters of bank at a time from a given location. The excavator would be positioned with the carriage 4-5 meters from the wall and the wheels parallel with the wall. The bucket would approach the wall from a vertical orientation with the tines penetrating the surface of the trench floor 0-7 centimeters to provide a very light raking of the materials embedded in the bottom as the bucket is moved toward the base of the wall with the stick. As the

tines approached the wall the operator would curl the bucket up while dropping the boom to bring the bottom of the vanes nearly horizontal as the tines made contact with the base of the wall. As the tines continued to penetrate the wall the operator used a combination of upward curl of the bucket combined with lowering of the boom to move the bottom cord of the bucket along an upward arc through the soil, without significant lifting. The object was to create a fracture from the base of the trench up to the soil surface without lifting the face of the bank. Once the fracture was created the operator would withdraw the tines along the same path by which they were inserted. This technique was developed

to avoid bringing the bucket up and catching the edge of a mine still embedded on the solid side of the fracture. The tines could penetrate 0.40 - 0.60 meters and create a correspondingly thick slice. Usually when the bucket is withdrawn the bank collapses downward under its own weight leaving the majority of AT mines exposed in the face of the bank. (See the fractured, uncollapsed bank face in the background of figure 10.) When a single pass was completed on a given section of wall the excavator would move forward 4-5 meters and begin again.

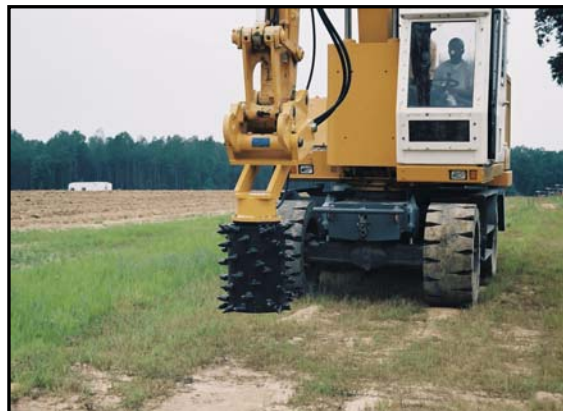
5 Figure 2. Vertical Mill

The second excavation tool is the Vertical Mill shown in figure 2. Like a machinist's mill, it is designed to shave the bank with a horizontal milling action. Although the cutting speed is much higher and the digging action more abrasive to the mines than the Vaned Bucket, the mill has the advantage of approaching the mine from the side, away from fuze triggers in normally oriented mines, much as the manual deminer's digging action. The Vertical Mill is intended as an alternative to

the Vaned Bucket for use in heavily rooted soils, hard soils which are resistant to the Vaned Bucket, or locations where precise control of the digging action is required. The mill rotates up to 170 rpm and features carbide tipped chisels. The chisels are “wear items” and can be replaced for \$450 per set. The mill is converted from a Bobcat Asphalt Planer with 24" drum. The mechanical interface for the mill was designed by Radian and fabricated by Night Vision. The Vertical Mill is manipulated with the existing Liebherr controls. Power for the mill is supplied by the Shinn HPU, and milling speed is set from the Shinn system joystick in the operator cabin. Approximately 60 kW of power is consumed by the mill in operation.

Several variables are available for controlling the digging performance with the Vertical Mill. Among the most important: the direction (forwards/backwards) of the stroke along the wall in reference to the fixed clockwise direction of spin when viewed from above, the depth (into the wall) of the cut, the height on the wall to begin a given cut (the mill is 0.70 m high, and the wall is 1-1.2 meters high).

A rearward stroke, that is moving the mill against the direction of spin produces a very aggressive cutting action. It is believed to be gentler on the mine cases because the maximum angle the mine must be transported through the soil is 1/4 of a rotation before reaching a free surface. Unfortunately this direction also produces a wide dispersion of materials coming off of the wall (see figure 12). The excavated soil layer although thin (<0.1 m beyond 1 m from wall), extends to 4.5 m from the wall and overlaps with the path of the excavator. A forward stroke, on the other hand, produces a very well behaved pile which lays in tight against the wall. The disadvantage to moving in this direction is a slower cut and a perceived rougher treatment of the mines since they must be pushed deeper into the bank for 1/4 of a revolution before movement toward the free surface for another 1/4 of a revolution. Mainly owing to the better dispersion of excavated soils, the forward stroke was chosen as the preferred direction for the majority of the testing. It is possible to envision a usage SOP with very tight monitoring of the

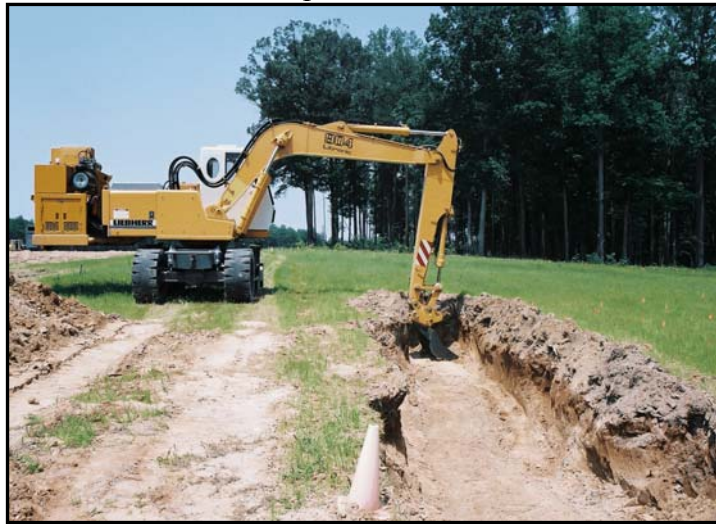
Figure 7. Working Across Trench

After completion of the starter trench the excavator was positioned adjacent to the trench on the “safe” side. The operator would reach across the open trench and down into the hole to perform the excavation (figure 7). The undercarriage was positioned parallel to the long dimension of the trench so the excavator could continually drive straight along the wall of the trench as the operator progressed down the length of the hole. The digging was performed with the undercarriage positioned approximately 1.2 -1.4 meters from the edge. Multiple passes made in this manner widened the trench to 5-6 meters at which point the excavator could no longer reach across.

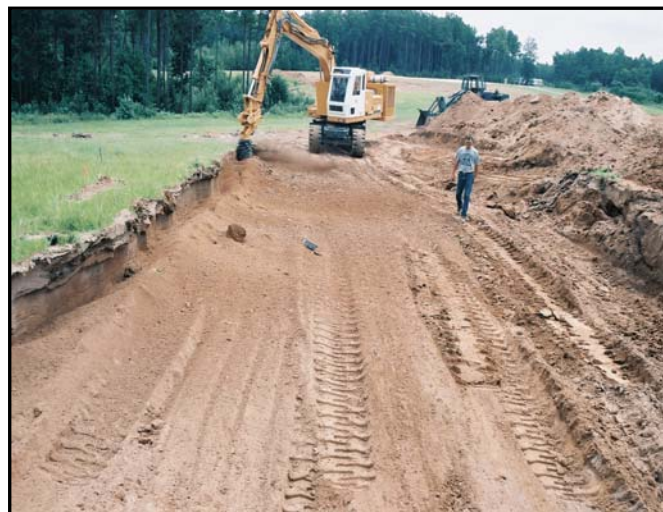
Figure 12. Vertical Mill Completing a Rearward Pass

vehicle path which would make the rearward stroke more attractive, however, the secondary problem of picking up the thinly dispersed soils spread far from the wall for sifting represents another inefficiency which would need to be overcome.

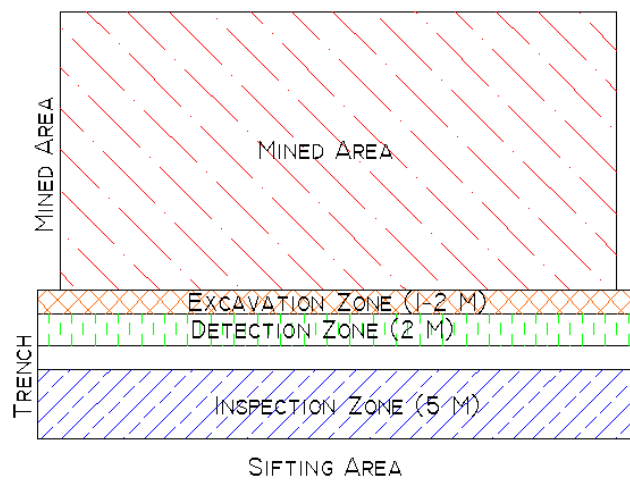
Figure23. Layout of Working Trench

excavator. The sifting action would be started and would continue until only large solid materials (heavy soil clods, roots, mines etc) remained in the bucket. The sifting action required approximately 15-30 seconds. When the sifting was completed, the bucket was again swung in the rearward direction and the contents emptied in the trail behind the excavator. Initially we had hoped to confine the residuals to a narrow band following the excavator tracks; however, experience dictated a wider spread to the residuals to keep the layer thin. In the end the area from the wheel track on the mined side of the trench over to the base of the clean soil pile was used for inspection of residuals. When the sifting pass was completed, the inspection team would again enter the trench and inspect the residuals with metal detectors. In addition to inspecting the residuals pile, a 2 meter zone beginning 1 meter from the wall out to the 3 meter point would be given a final check with the metal detector to ensure no mines had slipped by the process. The overall layout of the working process is diagrammed in figure 23.

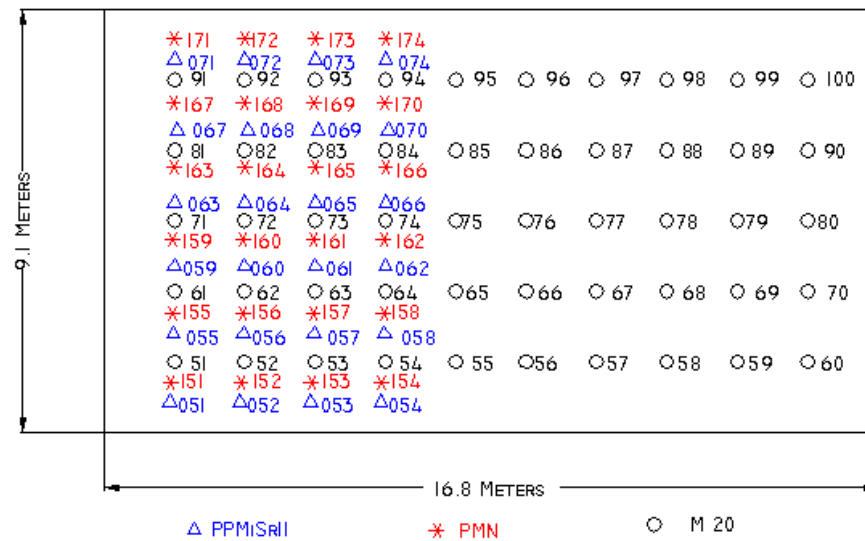
Layout and Mine Locations within Practice Area

AT Mines In Practice Minefield							
AT Mine Number	Burial Depth (cm)	Tool Used	Visible in Bank	Visible on Pile	Triggered in Recovery	Function Verified	Comments
51	10						Area Not excavated
52	10	Vaned	Yes	Yes	No	Yes	
53	10	Vaned	Yes	Yes	No	Yes	
54	10	Vaned	Yes	Yes	No	Yes	
55	10	Mill	Yes	Yes	No	Yes	
56	10	Mill	Yes	Yes	No	Yes	
57	10	Vaned	Yes	Yes	No	No	Mine was buried unarmed
58	10	Vaned	Yes	Yes	No	Yes	
59	10	Vaned	Yes	No	No	Yes	
60	10	Vaned	Yes	Yes	No	Yes	
61	20						Area Not excavated
62	20	Vaned	Yes	Yes	No	Yes	
63	20	Vaned	Yes	Yes	No	Yes	
64	20	Mill	Yes	Yes	No	Yes	
65	20	Mill	Yes	Yes	Yes	Yes	
66	20	Mill	No	Yes	No	Yes	
67	20	Mill	Yes	Yes	No	Yes

Appendix 1 maps the location of each mine and records the observations made as each mine was excavated, retrieved, and examined/tested for functionality. In the operational procedure planned for the Sifting Excavator each mine encountered would have 3 separate opportunities to be visually detected and recovered. The first is when the face of the trench is excavated and the mine is left exposed in the face as in figure 9. The second is when a portion of the bank collapses and the mine is visible in the spoils at the base of the mined face. The third opportunity is when the pile is picked up by one of the sifting buckets. Best practice would demand that a given mine be recovered at the first opportunity at which the mine was visually detected. For the purposes of gathering information on the efficiency of each step in the process, AT mines which presented

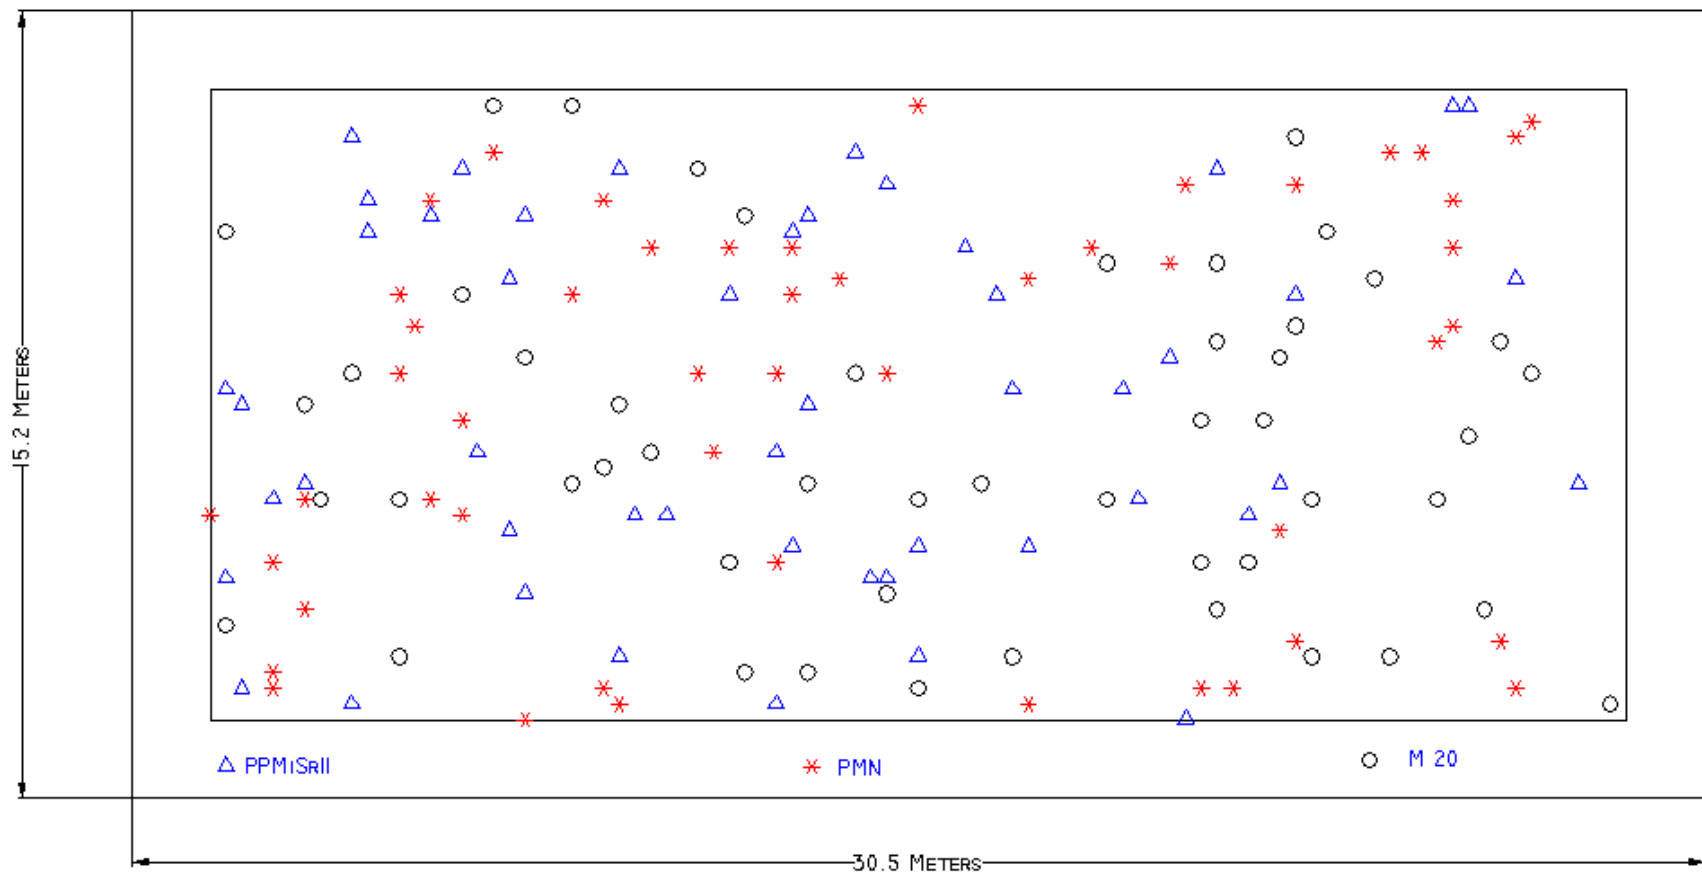
Mine Locations In Blind Minefield

AT Mines Blind Minefield					
Mine Number	Visible In Bank	Visible in Pile	Fuze Triggered	Function Verified	Comments
1	Yes 2:25 10/2/03	Yes 2:25 10/2/03	No	Yes 2:25 10/2/03	
2	Yes 2:00 10/2/03	Yes 2:00 10/2/03	No	Yes 2:05 10/2/03	
3	Yes 2:00 10/2/03	Yes 2:00 10/2/03	No	Yes 2:05 10/2/03	
4	Yes 2:00 10/2/03	Yes 2:00 10/2/03	No	Yes 2:05 10/2/03	
5	Yes 11:15 10/2/03	Yes 11:15 10/2/03	No	Yes 11:15 10/2/03	
6	Yes 2:00 10/2/03	Yes 2:00 10/2/03	No	Yes 2:00 10/2/03	
7	Yes 11:40 10/2/03	Yes 2:20 10/2/03	No	Yes 2:20 10/2/03

The proof of concept test was performed in a randomly laid, mixed minefield. Procedures similar to those which might be used in an actual mine clearance operation were employed and the operators had no knowledge of the mine locations. The same mine simulants as were used in the practice area were employed in the blind test: smoke fuzed antitank mines, PMN size/weight replicas, and PPMiSrII size/weight replicas. The size of the mined area measured a little over 12 by 28 meters. The mine locations within the field were randomly assigned and 50 of each type were emplaced. The antitank mines were buried 10 months in advance of the test to allow the soil to settle and vegetation to grow. 20% of the AT mines were buried 50 centimeters, 20% at 40 centimeters, 20% at 30 centimeters, 20% at 20 centimeters, and 20% at 10 centimeters. The AP simulants were buried one month in advance, approximately 10 to 20 centimeters. The minefield layout and mine locations are shown in appendix 2.
